Adam Afify is at Binghamton Johnson City Waste Water Treatment Plant. ...

1. Headworks leaking wall Picture #1, with electrical panels. –

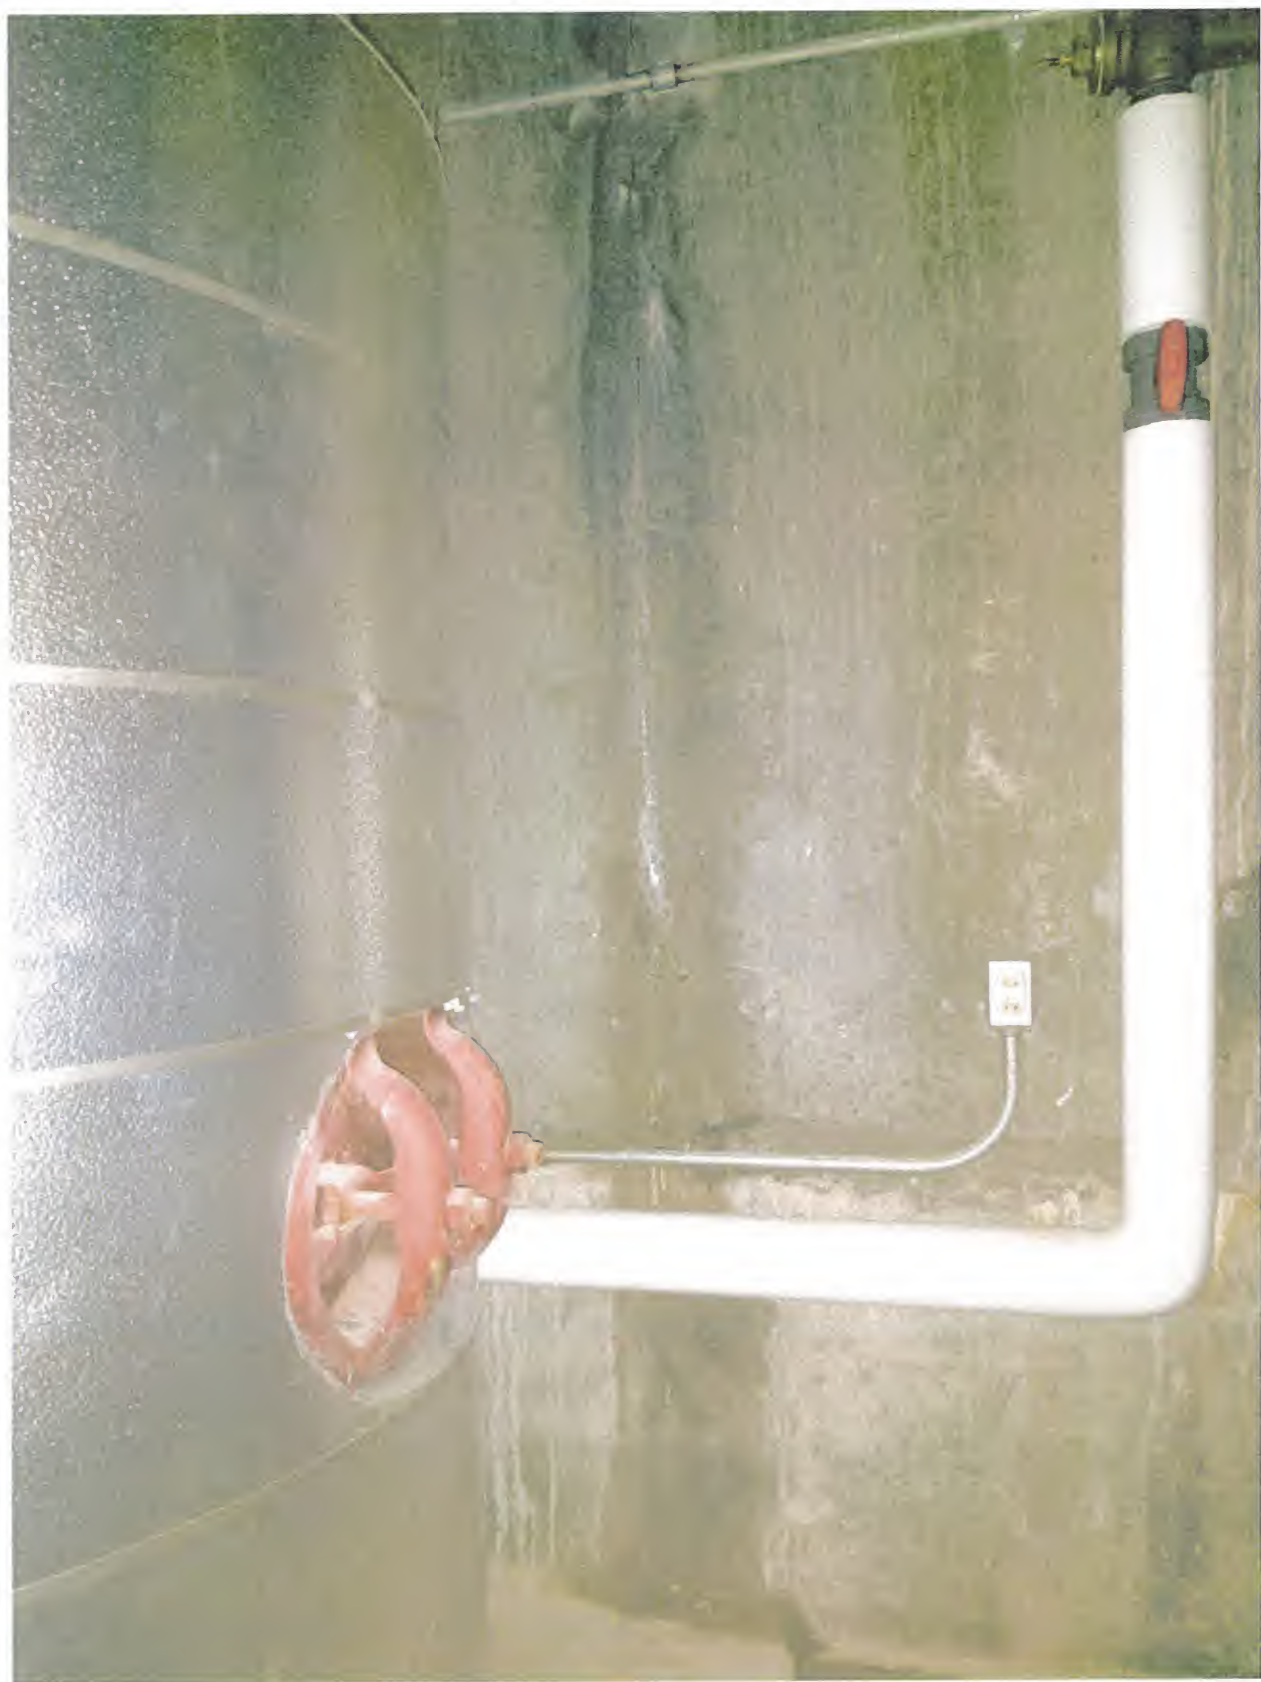
Alleged Condition – STP Staff alleges that the wall is leaking and is shoddy construction.

Actual Condition – This photo appears to be several weeks old. The headworks was put into service June 26 It does not show the completed work, and does not show that the leak has been addressed. The wall that the panels are located on backs up to the north grit channel. See attached drawing. The leak test on the channel was passed in January, 2019. All visible leaks were sealed at that time. At the time of the photograph, there are no visible leaks, just past leaks that were appropriately sealed during construction.

Alleged Condition - STP Staff also suggest that the control panels are covered in residue, and implying that they could be damaged.

Actual Condition – The issue is cosmetic, and it was addressed on the day that the picture was provided. These panels are not damaged. The streaky appearance is from water from the core drill process above the panels which ran down the wall. These panels have already been cleaned

up, and were not damaged in any way. The panels were inspected after the drilling process, and it was confirmed that the panels did not have any intrusion of water into the panels. Furthermore, the manufacturer certified the installation of the panels prior to putting the Headworks on line on June 26, 2019, and they confirmed that there were no warranty concerns.
